FOCUS ON THE ENVIRONMENT

A private- and novel- experiment in coast conservation

P. G. Cooray

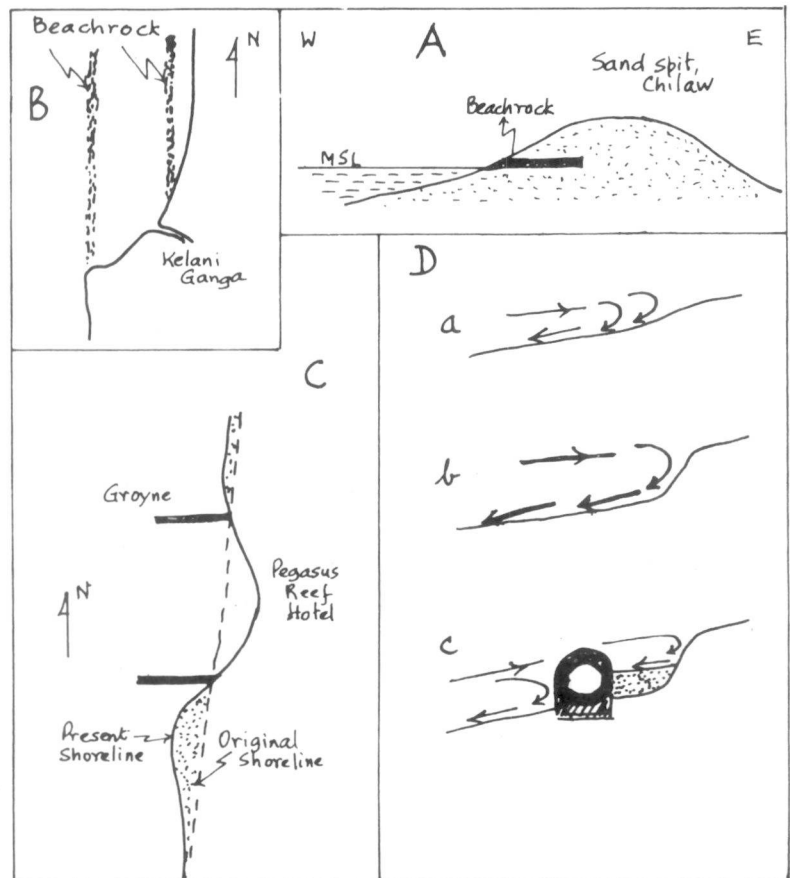
Fig. 1A. Diagrammatic section across the Chilaw sand spit to show the position of beachrock at the waterline.

1B. Diagrammatic sketch showing positions of the two beachrock reefs north of Colombo.

1C. Sketch plan showing changes in the shoreline opposite Pegasus Reef

Hotel after construction of the groynes.

1D. Diagrams to show the effect of placing a rubber tyre barrier on the shore.

a - original shape of shore.
b - shoreline after intensive erosion during south-west monsoon.
c - build-up of beach behind barrier.

Beachrock is known by geologists to form along the shoreline as a result of calcium carbonate being deposited in the sand by fluctuating groundwater, as can be seen today on the coast in the Chilaw sand spit (Fig. 1A).

Hence, any beachrock reef far out to sea marks a former position of the shoreline - and a former sea-level as well. Two such reefs can be seen at Uswetikeyawa (Fig. 1B).

For example, groynes have been built in front of the Pegasus Reef Hotel and the result has not been encouraging; the beach has built up south of the more southerly groyne, but increased erosion has taken place between the two groynes (Fig. 1C).

Mr. Wickramasinghe has adapted the methods described in the article to his own purpose and has placed on the beach a barrier to the under-tow that takes away the eroded sand from the beach (Fig. 1D and Fig. 4).

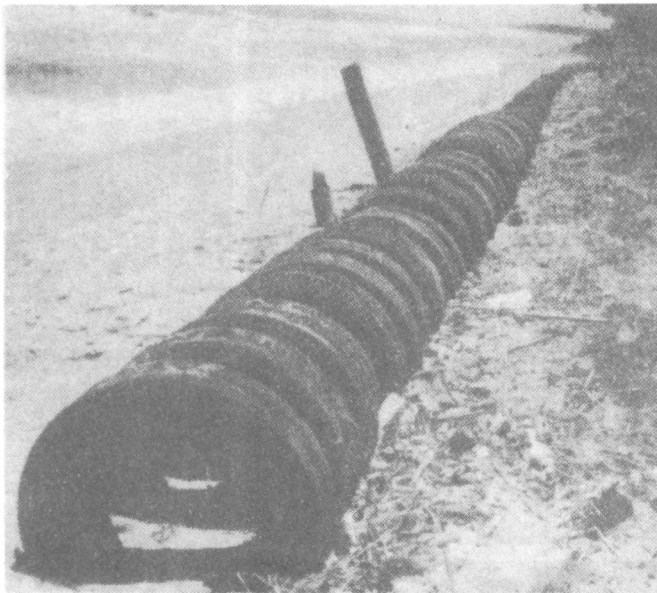
Tyre barrier mounted on the shore behind which eroded sand has accumulated.

These tyre structures are placed in line along the beach in front of his house a metre or so away from the shoreline (Fig. 4).

The success of the method so far, after a few months of being installed, can be seen clearly; where previously there was a sand cliff a metre or so high (Fig. 5), now there is hardly any sand cliff. The space between the barrier and the cliff has been filled in with sand (Fig. 4). Mr. Wickramasinghe hopes in future: (a) to place more structures close to the breachrock reef in varying positions, and (b) to place other barriers in relation to the present one.

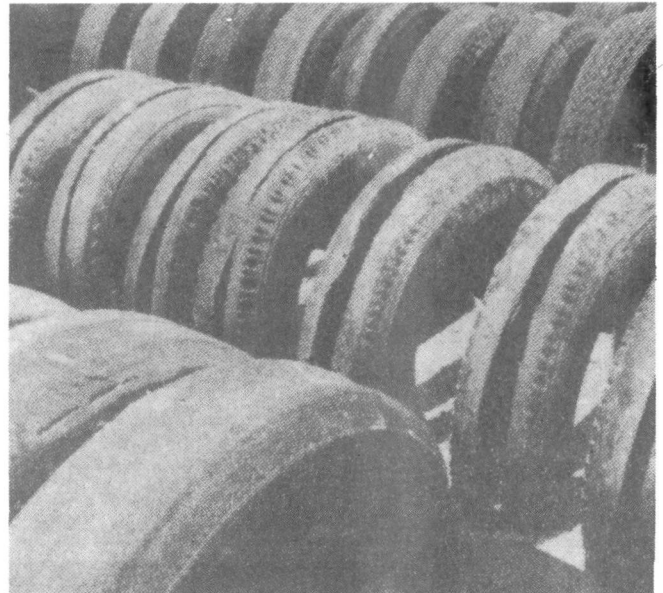
Mounted tyres slit vertically. (Daily News - 5.9.92)

The upper parts of the tyres are split lengthwise into two sections (Fig. 3) in order to reduce, somewhat, the undertow drag, and reinforced with iron rods.
