**PROPERTIES OF SOIL AND PLANT BIODIVERSITY IN THE LANDSLIDE PRONE  
AREA OF NIKOLA OYA, RATTOTA**

**Jinadasa Katupotha\* and Sumanajith Kumara**

**Department of Geography, University of Sri Jayewardenepura, Nugegoda**

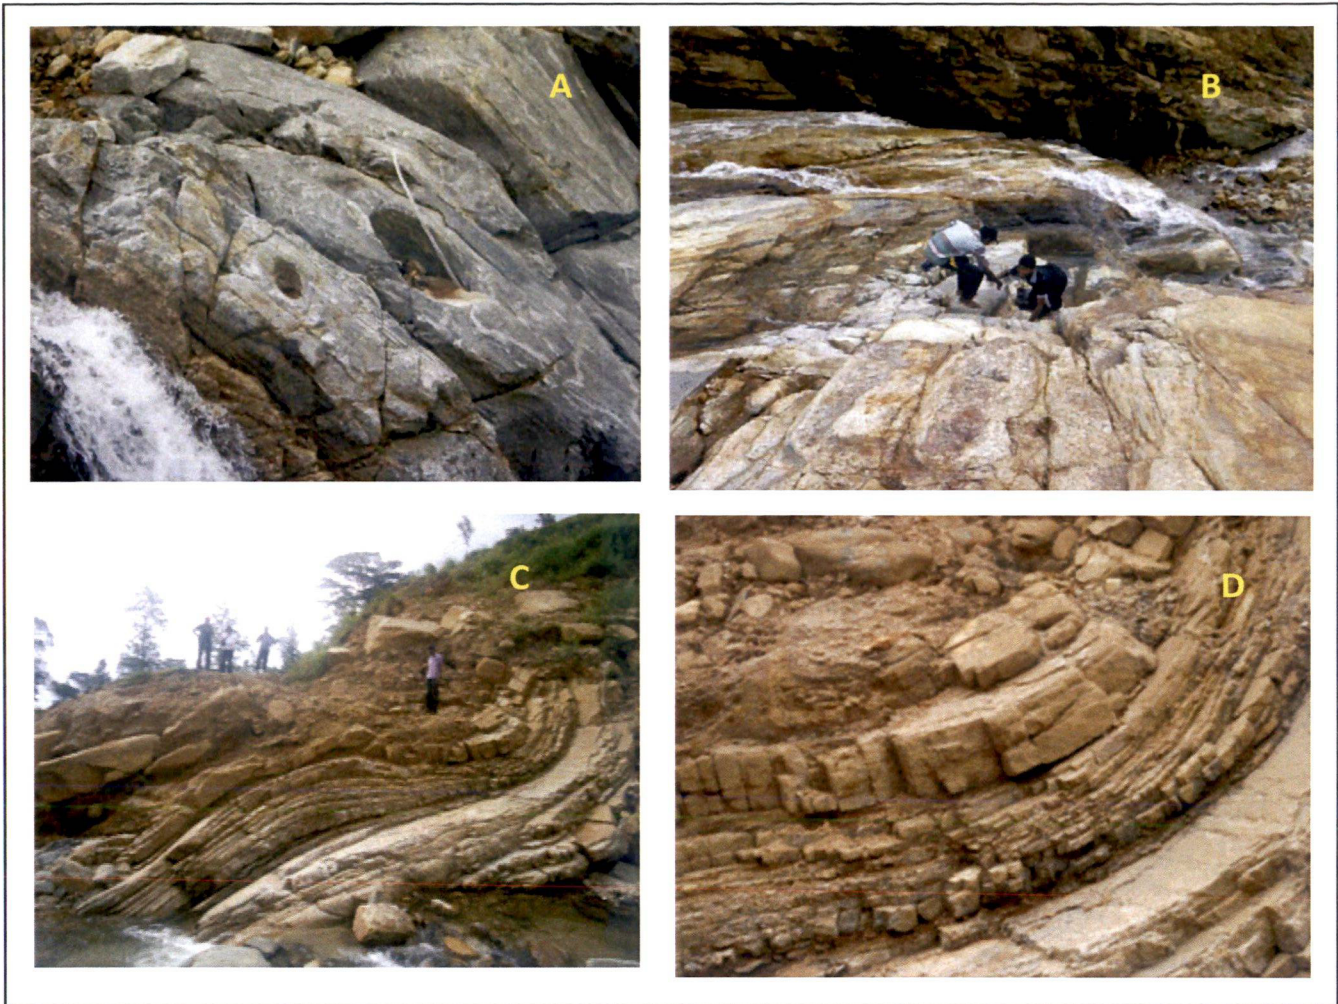
**Figure 1: Photos A-D show that the highly weathered undifferentiated charnockitic biotite gneisses (A & B), Quartzites (pure coarse-grained ridge forming quartzites locally with <5% each of sillimanite, kaolinized feldspar or biotite (C & D)).**

North-east of the Kandy Plateau is the Knuckles Massif, with several fine mountains over 1,600m, its highest peaks are Gombania (1,905m) and Knuckles (1,863m). The knuckles Massif is really a complex of ranges resulting from a large recumbent fold, and some of finest and most rugged mountains in Sri Lanka are to be found in this comparatively inaccessible and little known region (Cooray, 1984). Long escarpments, some rising over 900m in sheer rock walls are also common, particularly in the Knuckles area. These escarpments may be the results of faults but more often they are the result of jointing and some are resulted from the branching of long anti-clinal folds. Main rocks of the study area are Granite gneiss, undifferentiated charnokitic biotite gneisses, Quartzites (pure coarse-grained ridge forming quartzites locally with <5% each of sillimanite, kaolinized feldspar or biotite: Figure 1).

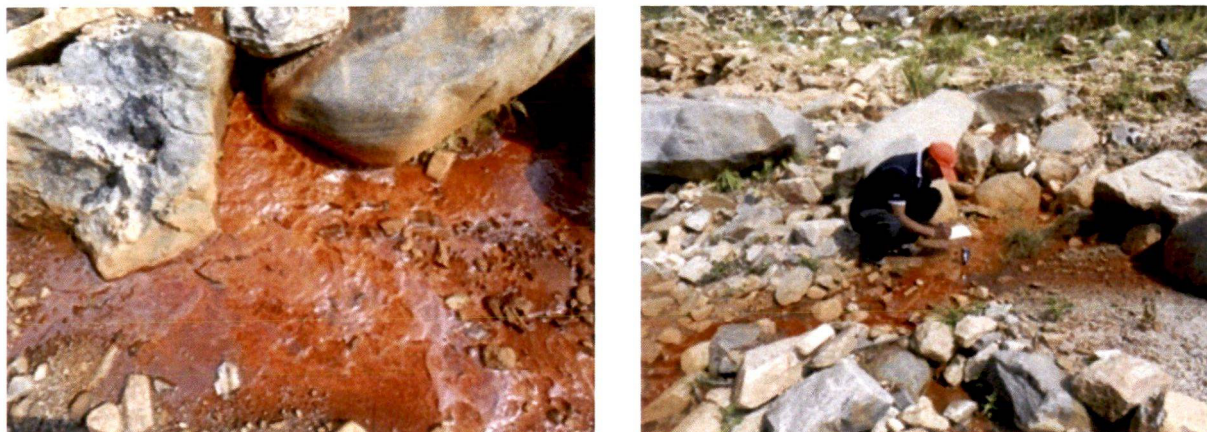
**Figure 3: Photos show that under the intense chemical weathering, *hydrated oxides* of Aluminum (bauxite) and Iron (goethite) concentrated water pockets are in the study area.**

Clay minerals are typically formed over long periods of time by the gradual chemical weathering of rocks, usually silicate-bearing by low concentrations of carbonic acid and other diluted solvents. These solvents, usually acidic, migrate through the weathering rock after leaching through upper weathered layers. In many places of the Nikola Oya it is possible to see goethite and hematite diluted solvents spring water pockets

In the Nikola Oya upper catchment, clay minerals are unstable and break down under intense chemical weathering to become *hydrated oxides* of Aluminum (bauxite) and Iron (goethite), which are very poor substitutes for clay minerals in retaining soil nutrients. As a result, jungle soil relies on the presence of humus, an organic substance produced by microbes that cause dead plants to decay; humus takes off the ability of clay minerals to retain soil moisture and nutrients.

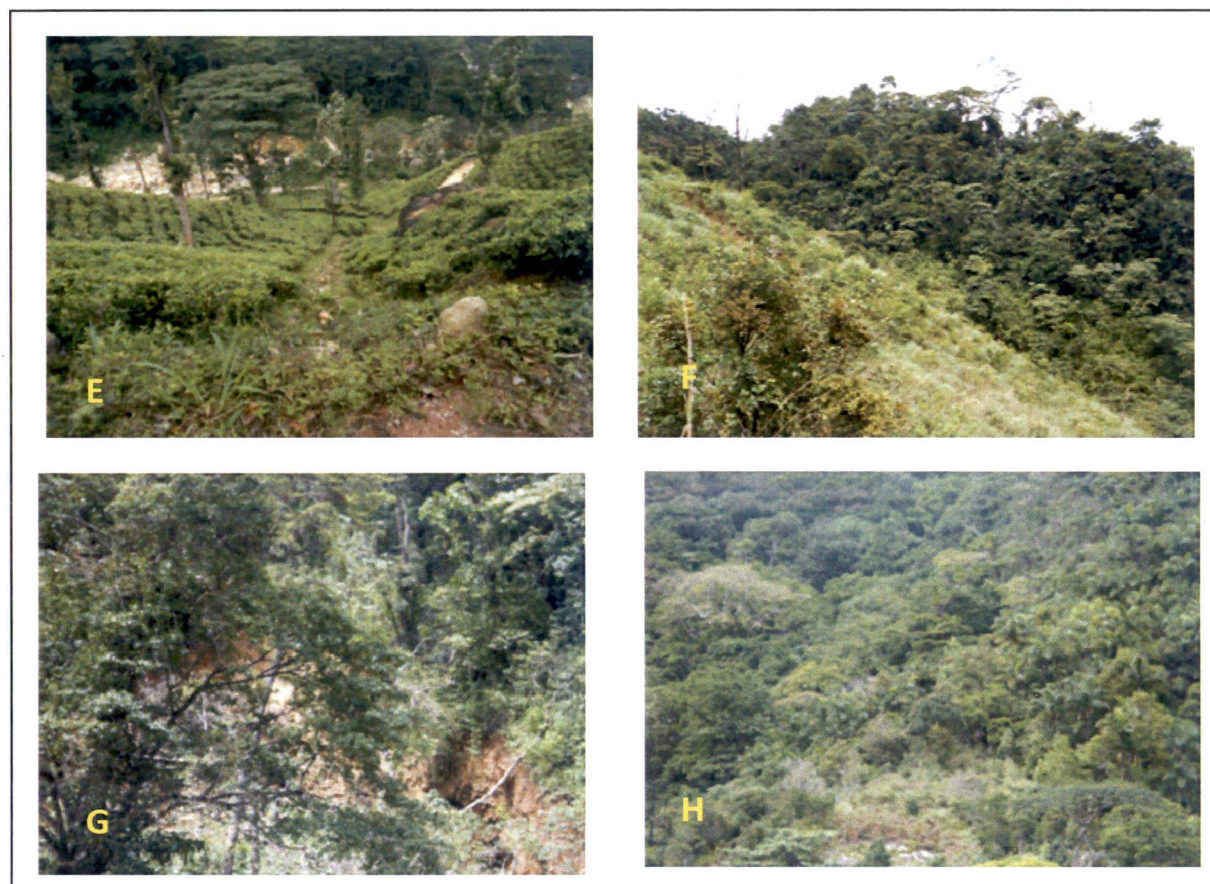
**Figure 4 : There is no thick soil cover in old agricultural lands (tea plantations, E, F & G). A thin top soil layer (with humus) has developed in Sub Montane Forests (H) of the Nikola Oya catchment, but the thicknesses vary according to micro morphology of forestlands.**

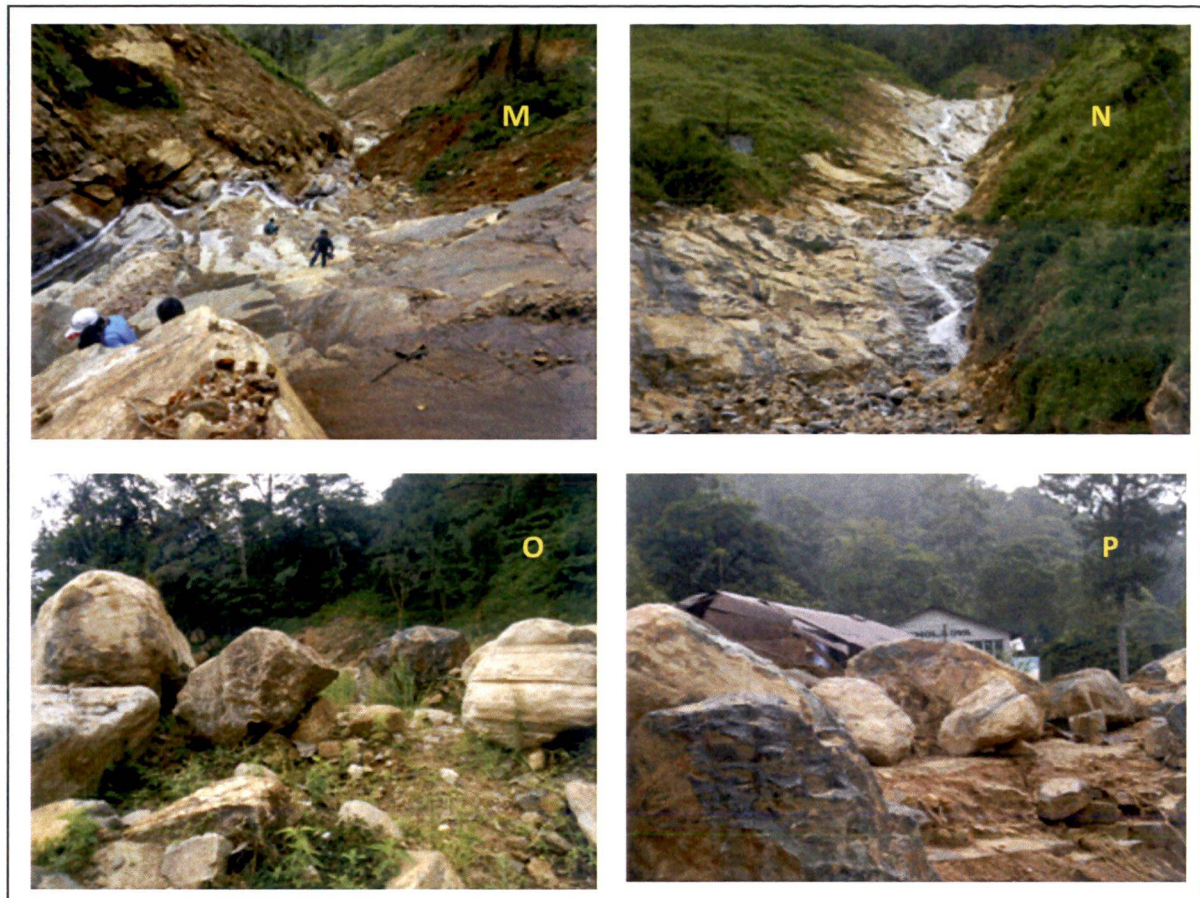
During the debris flow along the stream bed heavy abrasion process continued. By this mean, huge boulders rolling and collision fall to downward with other debris. Accordingly, some places of the stream bed appear gneissic bedrock surfaces and both sides show that there are no soil layers. The banded quartzite layers have broken due to the flowing of debris at this time, and boulders roll further down damaging houses and other properties located along the banks Figure 8.

**Figure 8: Photos M – P prove that heavy abrasion process continues during the flowing of debris on bedrock related river beds. The broken rocks scatter in low slopes and damage the houses and other property.**
